Protective Coating for Surfaces Operating Under Immersion

BELZONA®
5811

Belzona 5811 (Immersion Grade) is a solvent-free system for the protection of metallic and non-metallic surfaces operating under immersion conditions in contact with aqueous solutions.

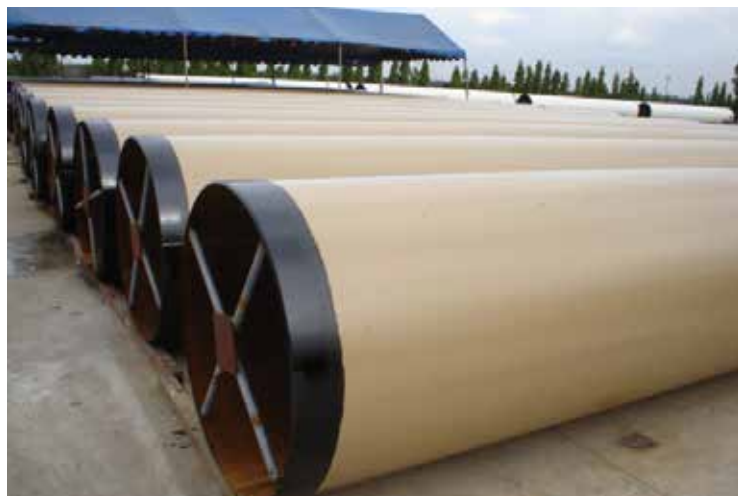
Belzona 5811 used for buried pipe protection

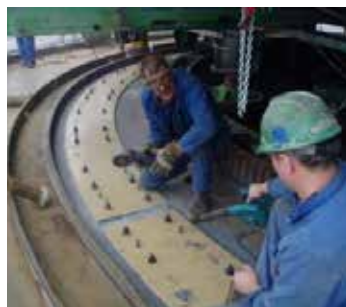
Injection bonding

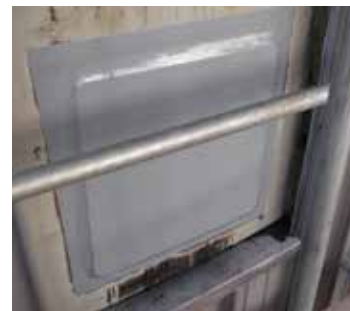
Protecting repairs

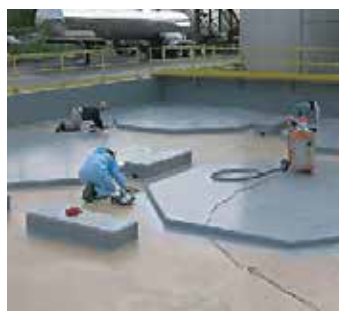
Protecting bunds

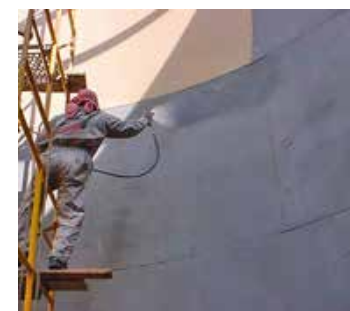
Lining tanks
