# Spray-Applied Protective Coating for Process Equipment Operating at Elevated Temperatures

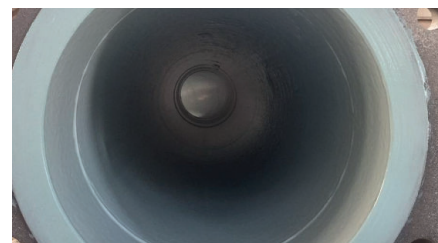
The light colours of Belzona 1523 allow easy visual inspection in vessels.

- Boiler vessels
- Condensers
- Heat exchangers
- Flare knock-out vessels and evaporators
- Separators
